# RADER-WOLF-COUGAR WATERSHED ANALYSIS

First Iteration

20 September 1996

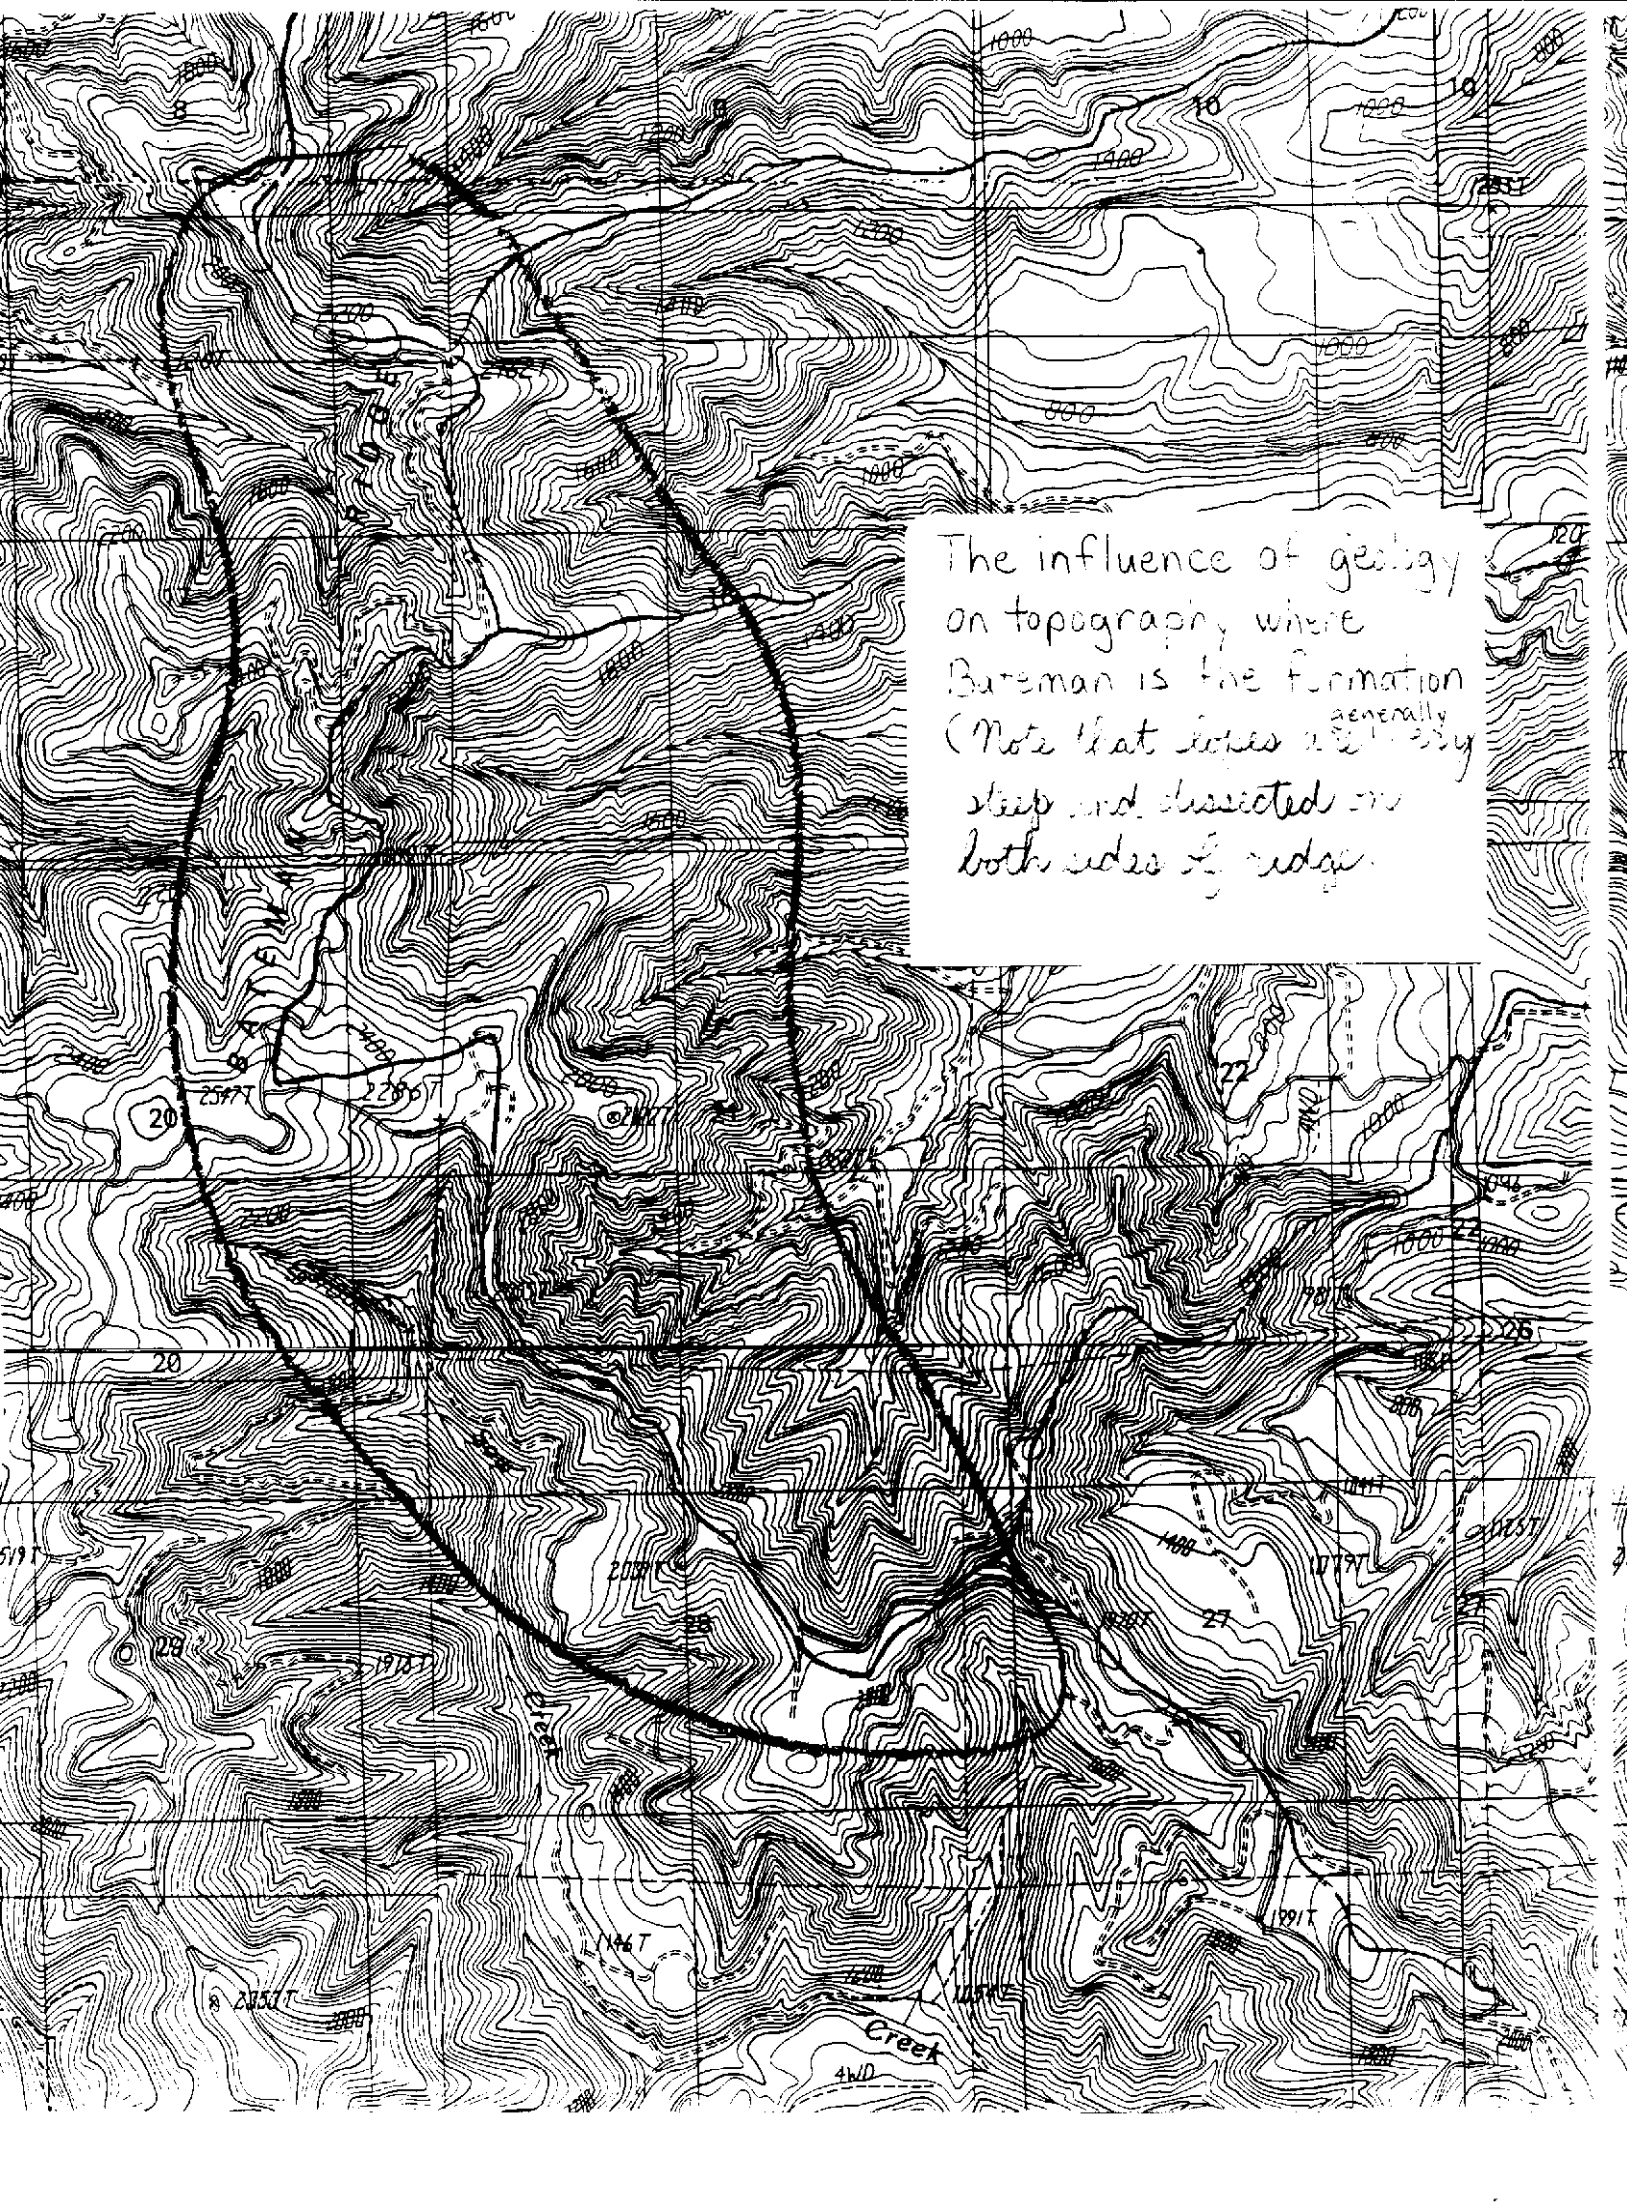
Figure II - Z(a-e)

Characteristic Topographies

Tyee Formation consisting of sandstones interbedded with some siltstones

Elkton Formation

Example of the effect  
of dip in the Tyee  
Formation

Direction of dip  
of strata

The influence of geology  
on topography where  
Bartman is the formation  
(Note that slopes are <sup>generally</sup> steep and dissected on  
both sides of ridge.)

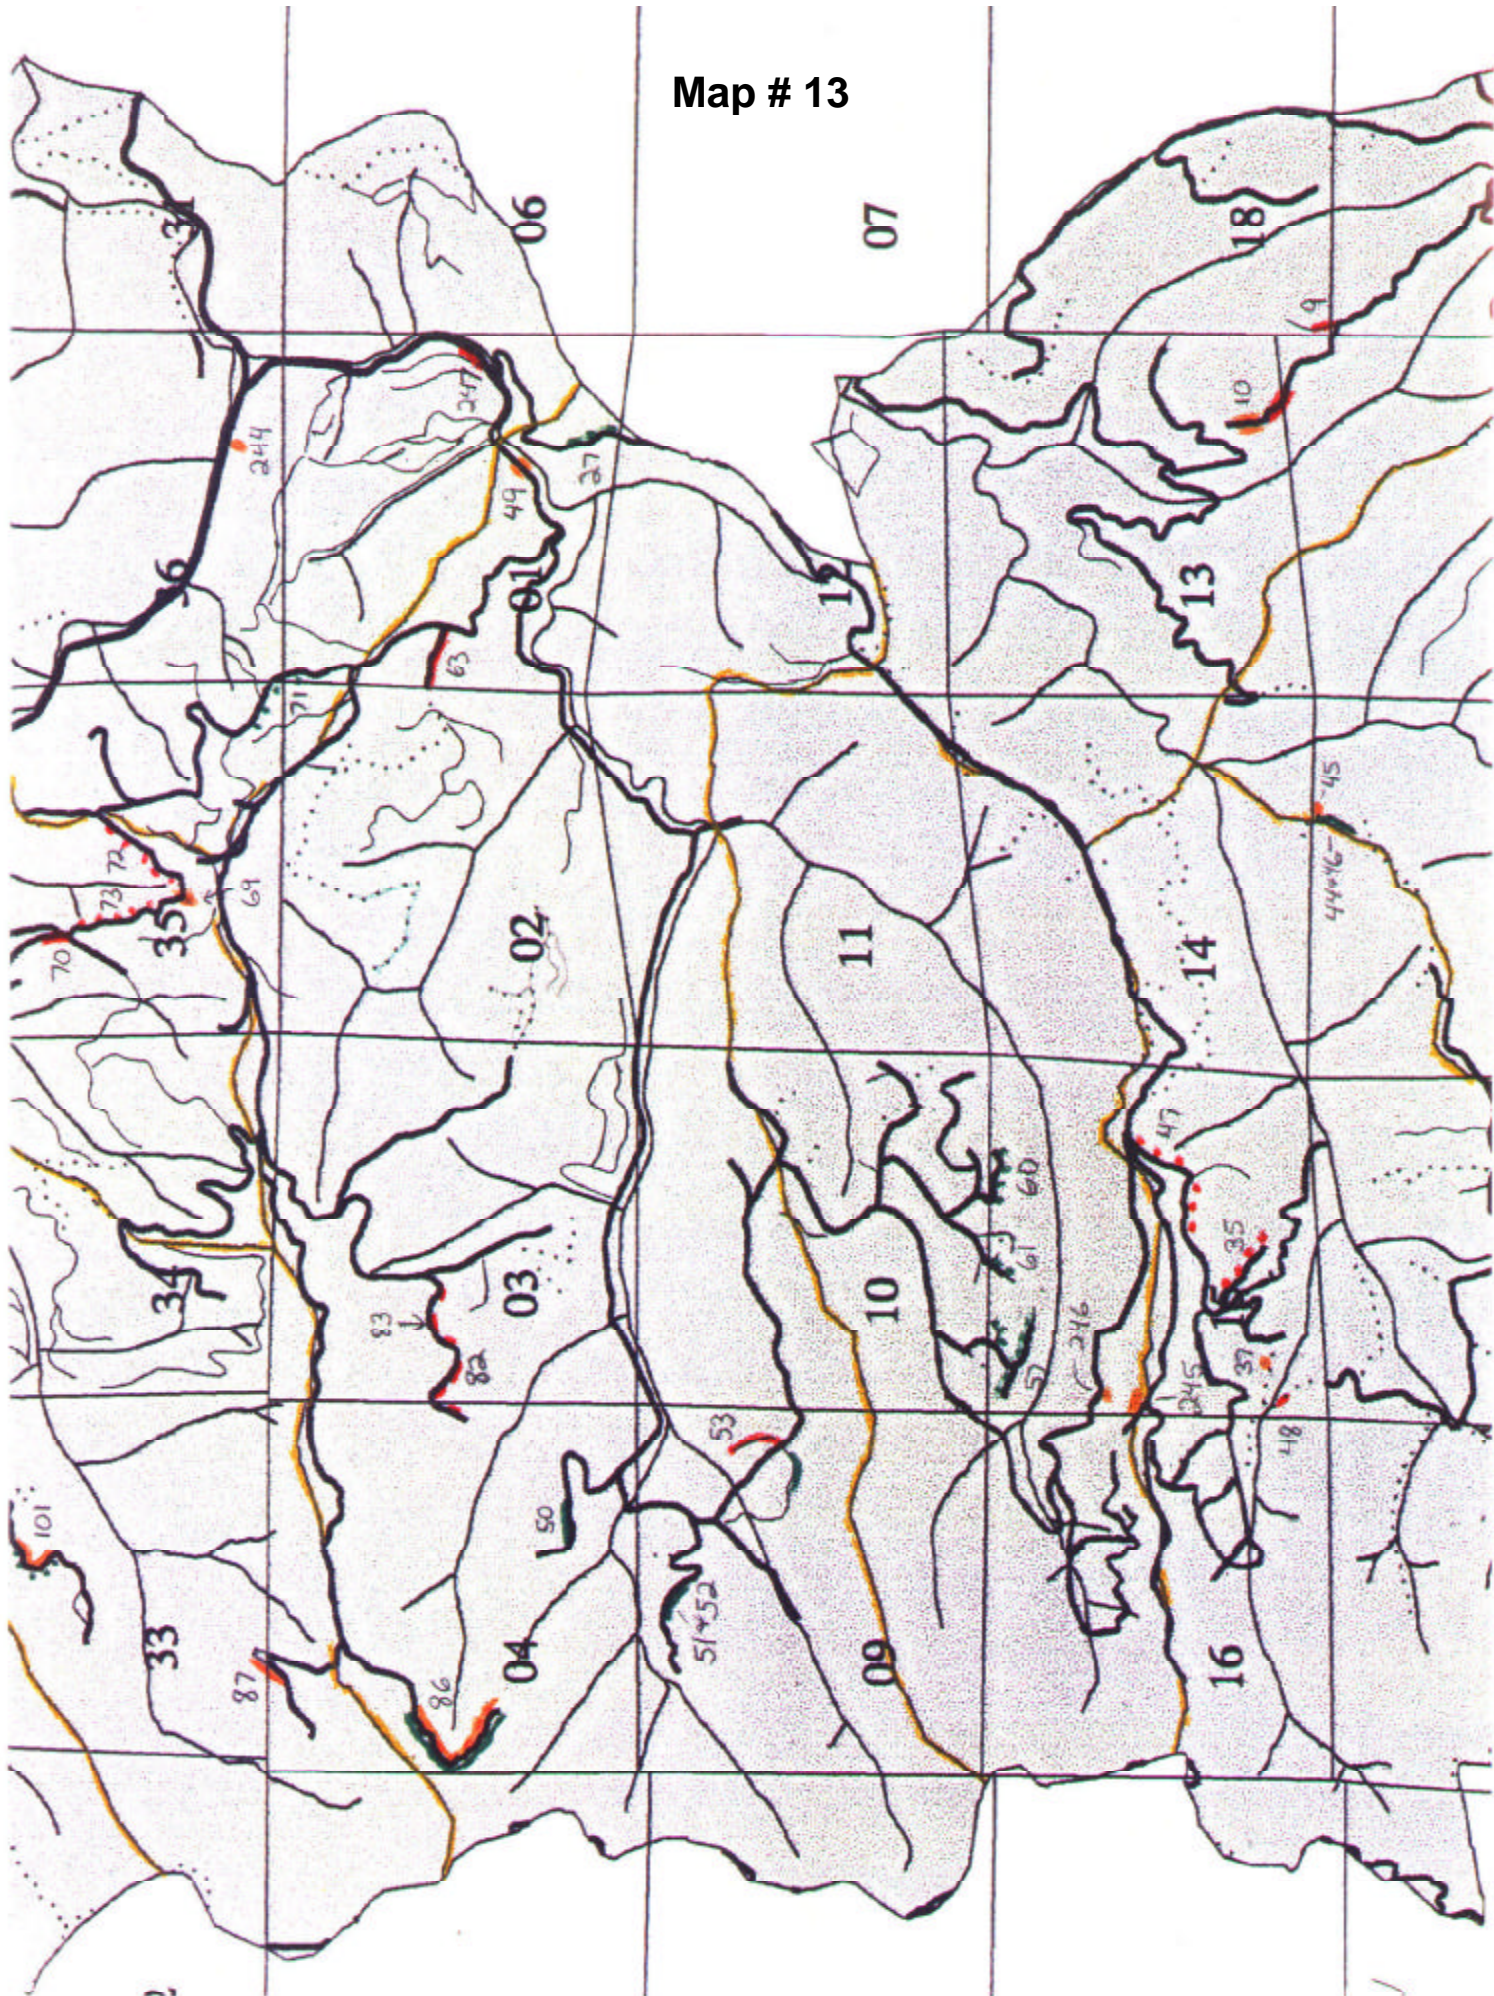
## Legend for Field Identified Road Problems

Figures II-11 through II-14 mark the location of current road problems which were noted recently in the field. Table II-14 and comments give a written description of the location and nature of the problem. Those of moderate priority for corrective action are marked with a check. Those judged to be high priority are marked with a double check. No check denotes low priority. The problems noted are only on those roads controlled by the BLM and on privately controlled roads where they are on BLM surface.
